BLUES POND DAM

PHELPS COUNTY, MISSOURI

MISSOURI INVENTORY NO. 31538

PHASE I INSPECTION REPORT
NATIONAL DAM SAFETY PROGRAM

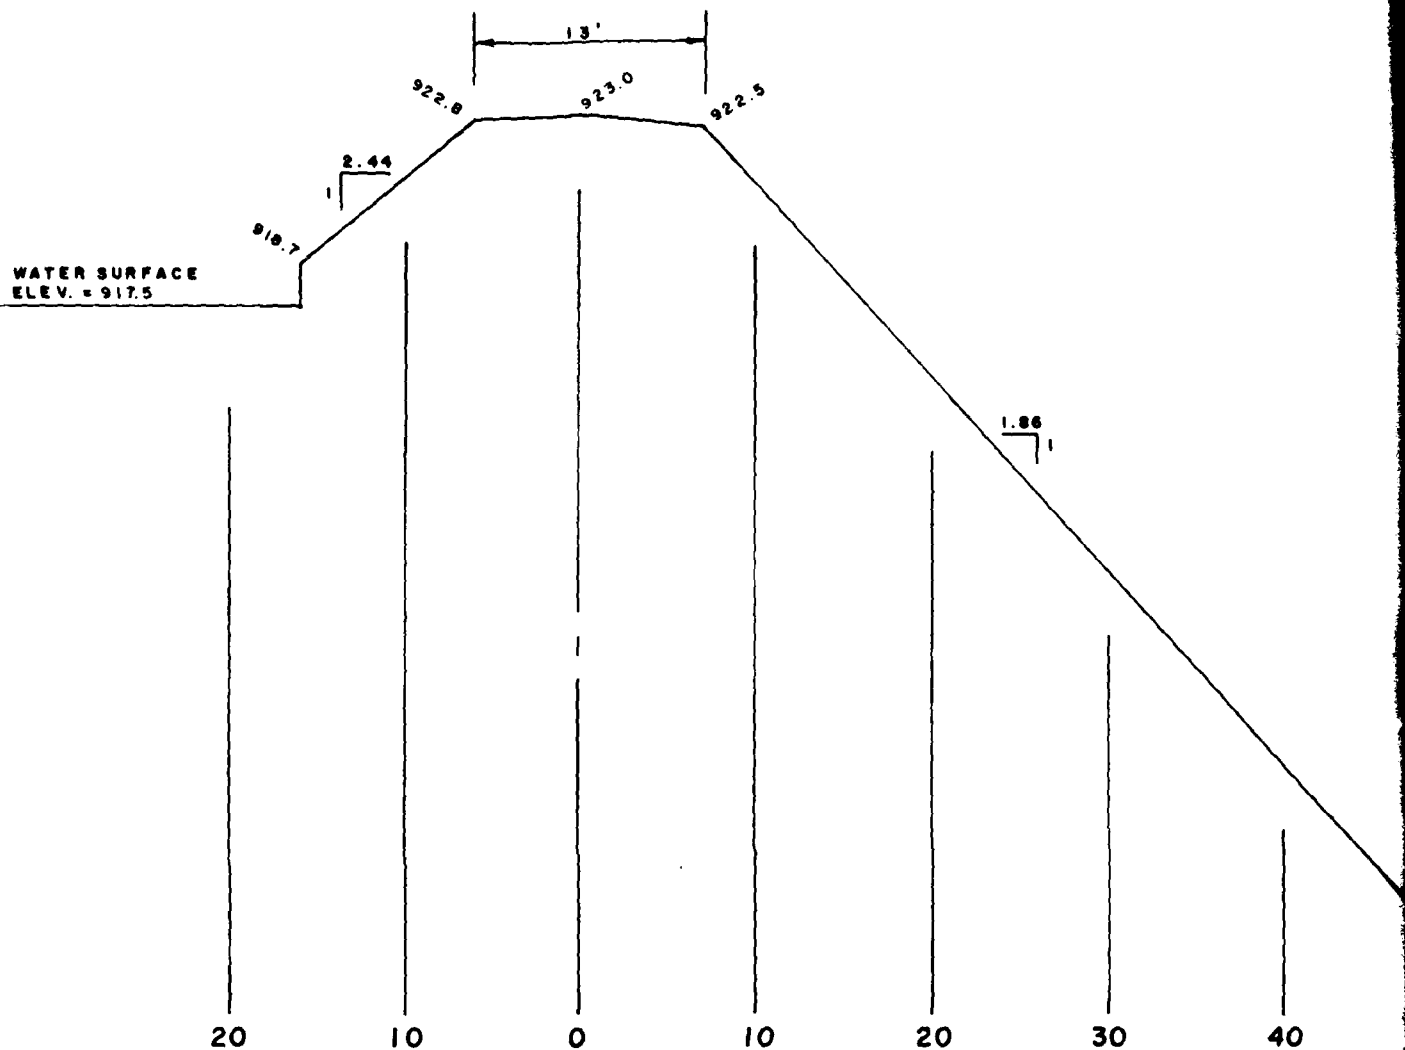
SECTION A-A STA 3+00

The downstream face is moderately covered with trees and brush and is fairly steep (survey indicates slopes between 1.7 and 2 horizontal to 1.0 vertical). A small slough was noted near the crest at approximate Station 3+00. A few small animal holes were noted. No seepage was noted at the base or through the dam. Shallow auger probes in the dam encountered a brown clayey silt to silty clay material (ML-CL). Photo No. 6 shows the downstream face. Sheet 5 of Appendix A presents a plan sketch of the dam showing observed features.

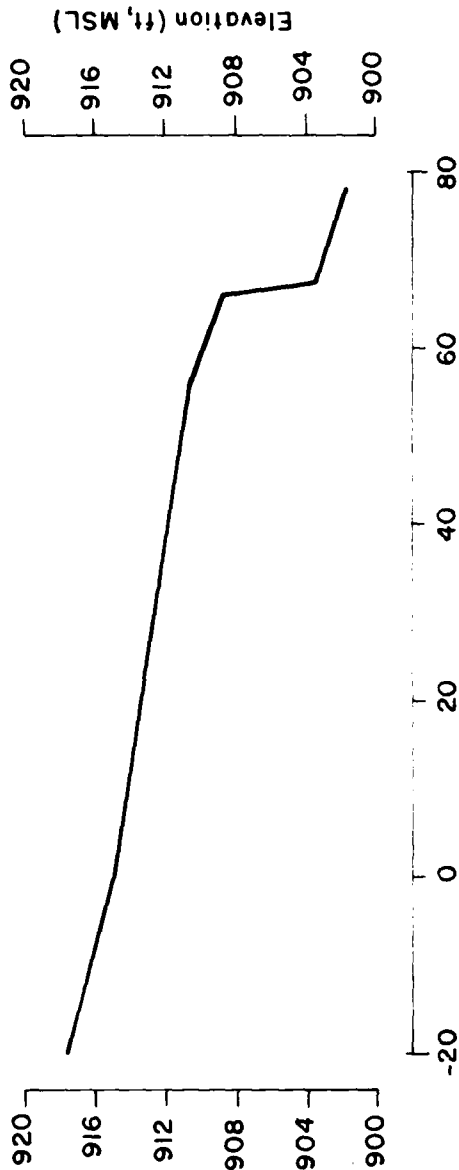
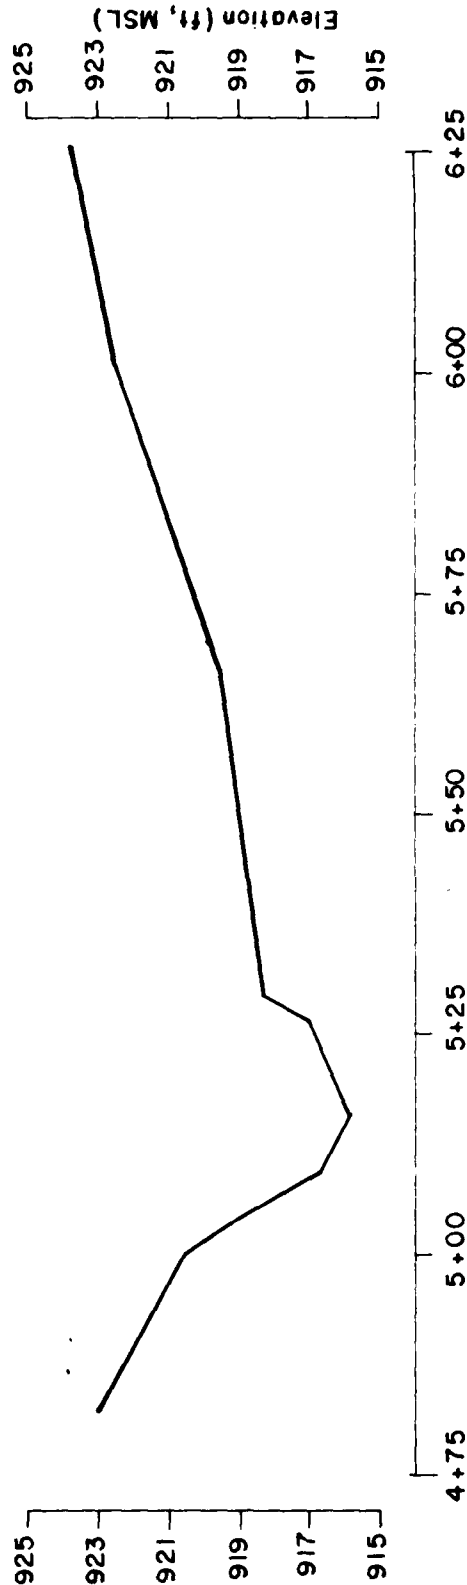
PROFILE & SECTION OF SPILLWAY

The spillway is a trapezoidal cut in the left abutment with concrete paving in the upper portions of the spillway (see Photos 7 through 15). The slab has experienced some cracking, and a hole in the slab was noted as shown in Photo No. 12. Apparently, water is entering the hole and causing some undermining of the slab. A pile of concrete rubble and rock was placed on the right side of the slab downstream of the hole (see Photo No. 13) in an apparent effort to reduce soil loss from under the slab. Some grading has been done recently in the approach area of the spillway on the dam side. This area would appear to be
